**MIL-DTL-901E SHOCK TEST REPORT OF THE
VARISTAR SPRING ISOLATED CABINET
PERFORMED ON THE
DECK SIMULATING SHOCK MACHINE (DSSM)**

Purchase Order Number: 709877OS

Issue Date: 06 April 2023

Prepared for: Schroff, Inc.
170 Commerce Drive
Warwick, Rhode Island 02886

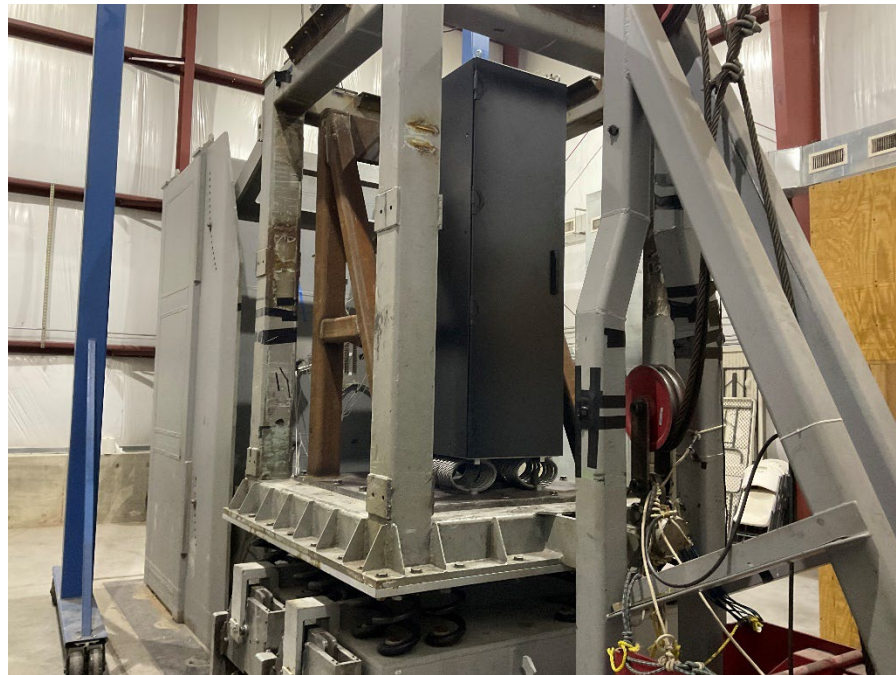
Photograph 1: EUT on DSSM for the Shipboard Axis

A test fixture fabricated in accordance with NTS Drawing No. PH00005037 was used to interface the EUT with the DSSM for both the Shipboard and Rotated axis (Photographs 1 and 2, respectively). The EUT attached to its test fixture using the following hardware: (Sway) quantity four (4) ½"-13 Grade 8 Flat Socket Head Bolts, four (4) ½"-13 Grade 8 Self-Locking Nuts, and four (4) ½" Flat Washers / (Base) quantity sixteen (16) 3/8"-16 Grade 8 Flat Socket Head Bolts. The test fixture was attached to the DSSM cage using Qty. twelve (12) 1-8 Grade 5 Hex Head Bolts, flat and lock washers.

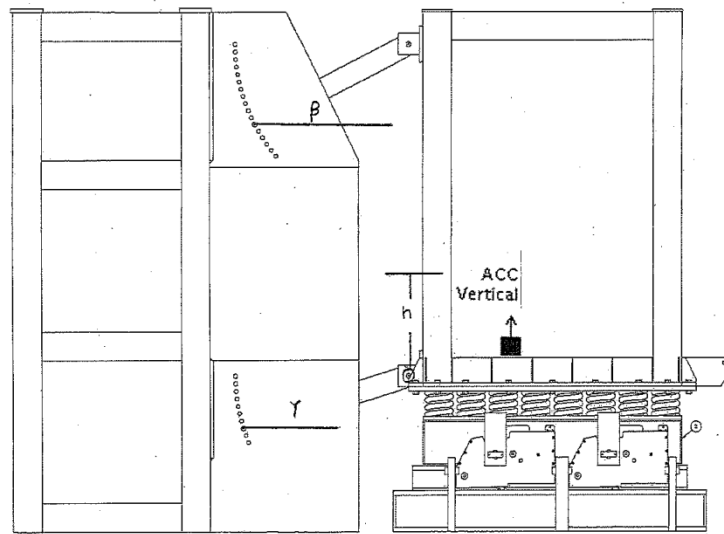
Figure 1: DSSM Setup

The test parameters used to set the DSSM are the upper swing arm angle β , the lower swing arm angle γ , and the drop height h as shown in Figure 1. The angle β controls the rotational input velocity, the angle γ controls the Athwartship input velocity, and the drop height h controls the vertical velocity.

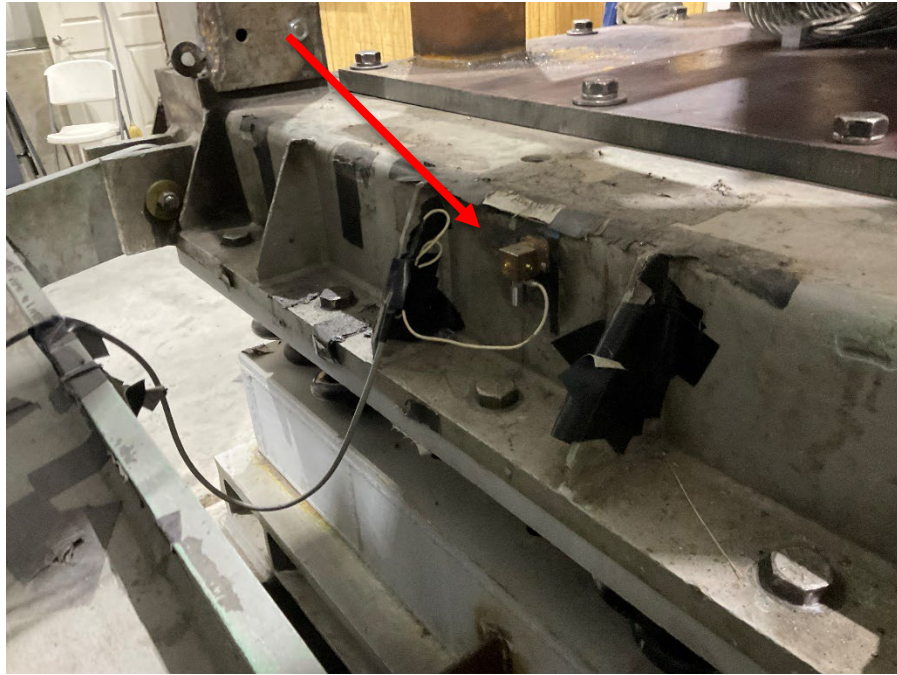
Photograph 3: ACC101V Location

One (1) input (relative to the machine orientation), three (3) response accelerometers (ACC), were used during the test series to monitor the shock response of the DSSM and the EUT. Instrumentation locations are listed in Table 3. Time-history traces for each sensor are included as Attachment A. Test instrumentation locations are shown in Photographs 3 and 4. In addition a video was taken of each drop. All test and measurement equipment used was calibrated in accordance with ISO-IEC 17025. One 3” clay cone was installed under each base isolator to gauge isolator excursion.

Sensor ID	Serial #	Sensitivity	Gauge Range	Sensor Location	Calibration Due Date
ACC101V	17801	0.436	2000	DSSM Input	4/5/2023
ACC201V	EL526	0.356	2000	Top Right Front Corner	7/29/2023
ACC202FB	EL557	0.361	2000	Top Right Front Corner	7/29/2023
ACC203SS	EL561	0.394	2000	Top Right Front Corner	7/29/2023

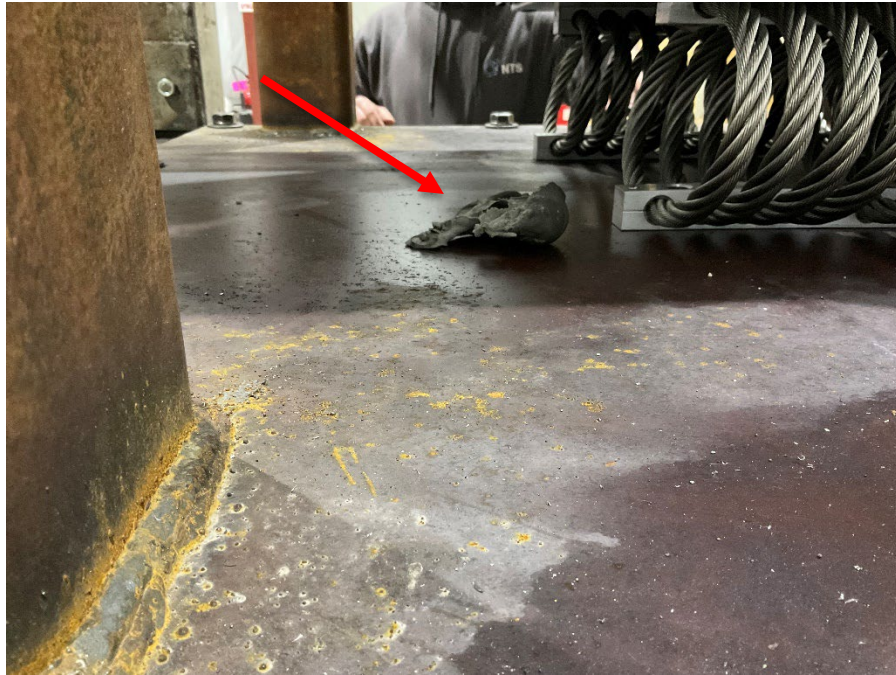
Photograph 5: Crushed Clay Cone – Right Rear Base Isolator

Observation: No deficiencies or discrepancies were noted with the EUT. It was noted the Rear Base Isolators appeared to have bottomed out. (See Photograph 5)

Resolution: None required.

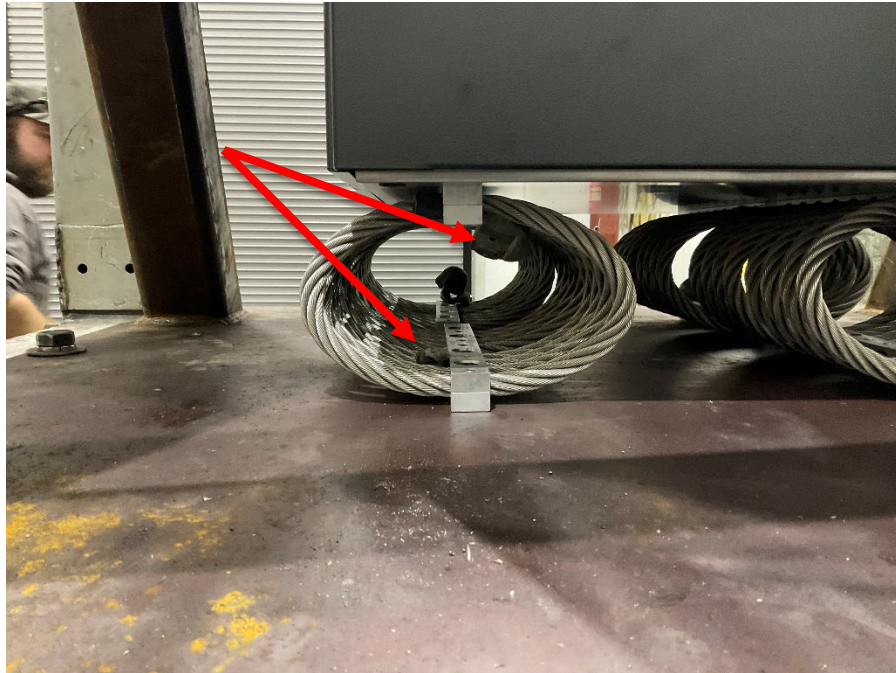
Photograph 6: Crushed Clay Cone – Right Rear Base Isolator

Observation: No deficiencies or discrepancies were noted with the EUT. It was noted the Rear Base Isolators appeared to have bottomed out. (See Photograph 6)

Resolution: None required, testing concluded.
